YURALPA, ECUADOR

CUSTOMER ENCOUNTERS CASING RUNNING PROBLEMS AND RE-RUNS THE SAME CENTEK CENTRALIZERS ON THE SECOND TRIP DOWN

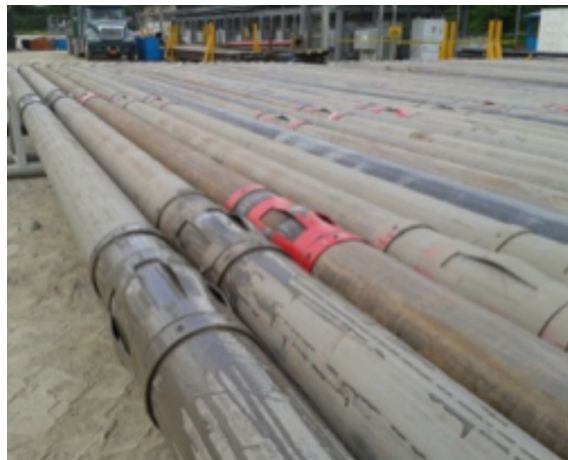
All Centek centralizers and stop collars were recovered and inspected to be found in good condition. The stop rings had not moved and the centralizers were still in their original positions on the casing. There were areas where the powder coating had been removed, but there were no signs of bent bows or bent centralizers. After the clean out and well conditioning trip, the very same Centek centralizers and stop collars
