PETROAMAZONAS, ECUADOR

SUCCESSFUL LINER RUNNING OPERATION AND RECIPROCATION ACHIEVED ON BOTTOM, ALLOWING EFFECTIVE CEMENT PLACEMENT ON THIS CRITICAL LINER JOB

Field: Oso

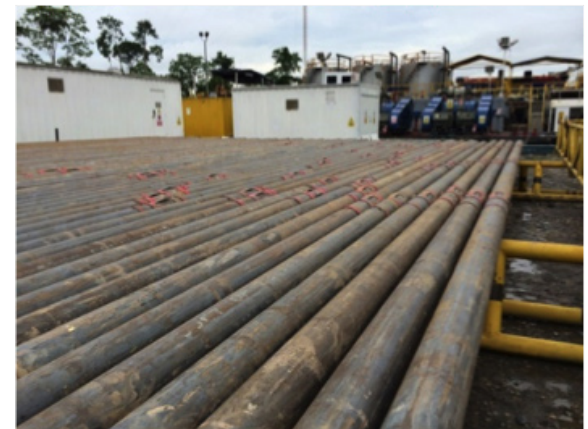
Halliburton proposed using the Centek S2 7" x 8 1/2" centralizers. These were chosen for their ruggedness and best selection for passing through the KOP exit window without problems (not once but twice!). Halliburton Icem and Centek Latload modeling recommended locating two centralizers per joint mostly all along the open hole to give the best possible stand-off and chances of success with this cement job.

Simulations showed that running the liner and achieving good cement sheath would be possible. Halliburton pumped an ElastiCem Wellife slurry on this job to provide optimal zonal isolation along productive life of the well, which has various pay zones.

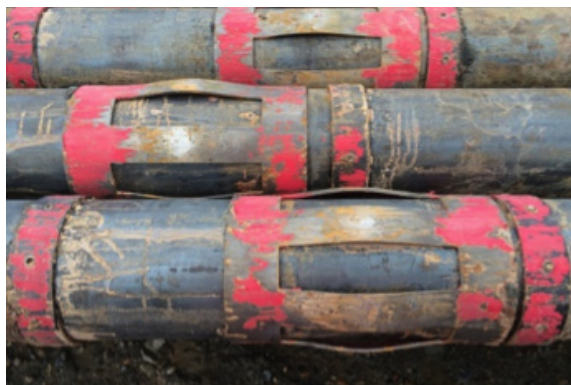
The production 7" liner reached TD without any problems. Due to torque limitations it was not possible to rotate the string when on bottom, but the Operator was able to reciprocate during circulation and cementing job. This allowed for good mud displacement efficiency and placement of cement all along and around the liner, despite the heterogeneous conditions of wellbore. This was reflected in the cement bond log.

The Centek S2 single piece construction gives it robustness and strength which exceeds that of competitor products. Although Centek does not recommend the re-use of centralizers after they have been pulled out of hole this case study proves that even when subjected to extreme stresses the unique design of Centek centralizers meant that they remained in good condition and could be re-run.

In the first liner run there were external conditions that created packing-off during circulation. Close to TD the liner had to be pulled out of hole. All centralizers and stop collars were recovered in good shape.

After the conditioning trip the very same Centek centralizers and stop collars were inspected and all were re-used in the second liner run, avoiding extra costs and awaiting delivery of additional centralizers.
